DENEY RAPORU

TEST REPORT

Numunenin adı ve tarifi : PRONİL Intumescent seals "INTUFLAME, INTUFLAME H"
Name and identity of test sample

Fire resistance test, in conformity with the general requirements of standards EN1363-1:2012, with substitute or additional methods of standard EN1363-2:1999 and with the particular requirements of standard EN 1366-4+A1:2010 "Fire resistance tests for service installations - Part 4: Linear joint seals".

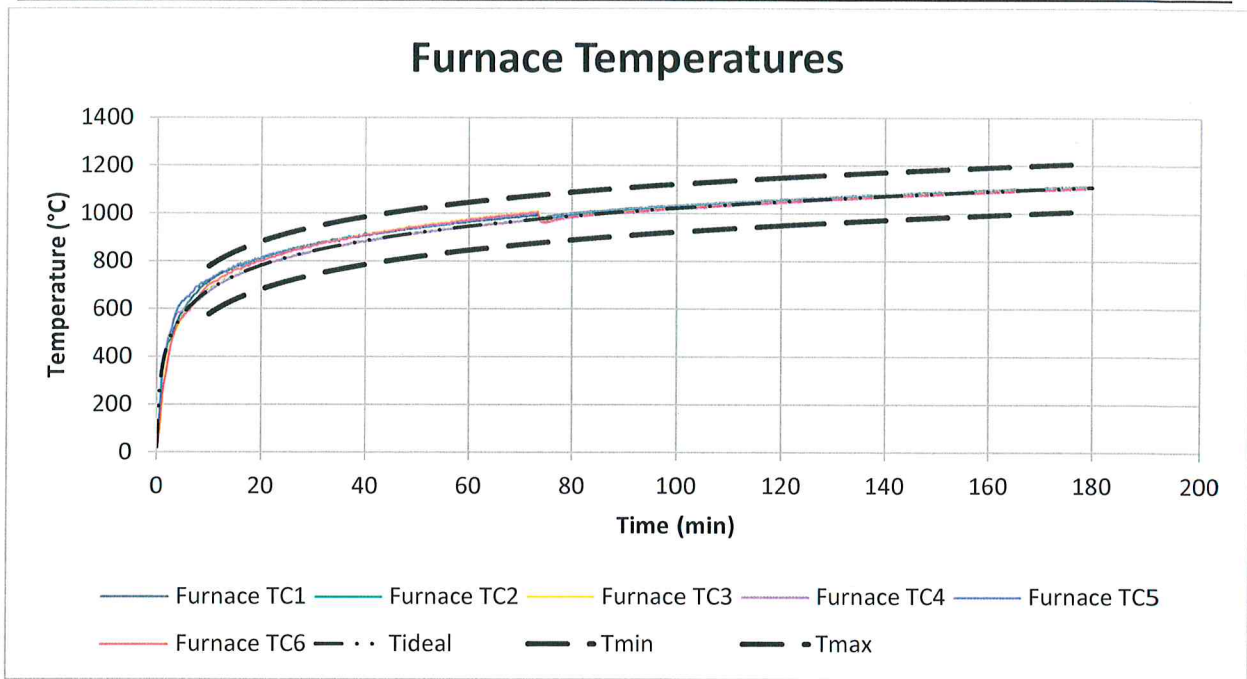
Figure A1: Furnace Temperatures

- Ambient temperatures inside the furnace with six plate thermocouples (Furnace TC1 to TC6), evenly distributed over the directly heated surface (see figure A1).
- The pressure in the furnace (see figure A3).
- Ambient temperature in the laboratory (see figure A4)
- The surface temperatures on the unexposed side of the test specimen (TC 3 up to TC34), see figure B2—B5).
- Deformation of test construction (see figure B6)

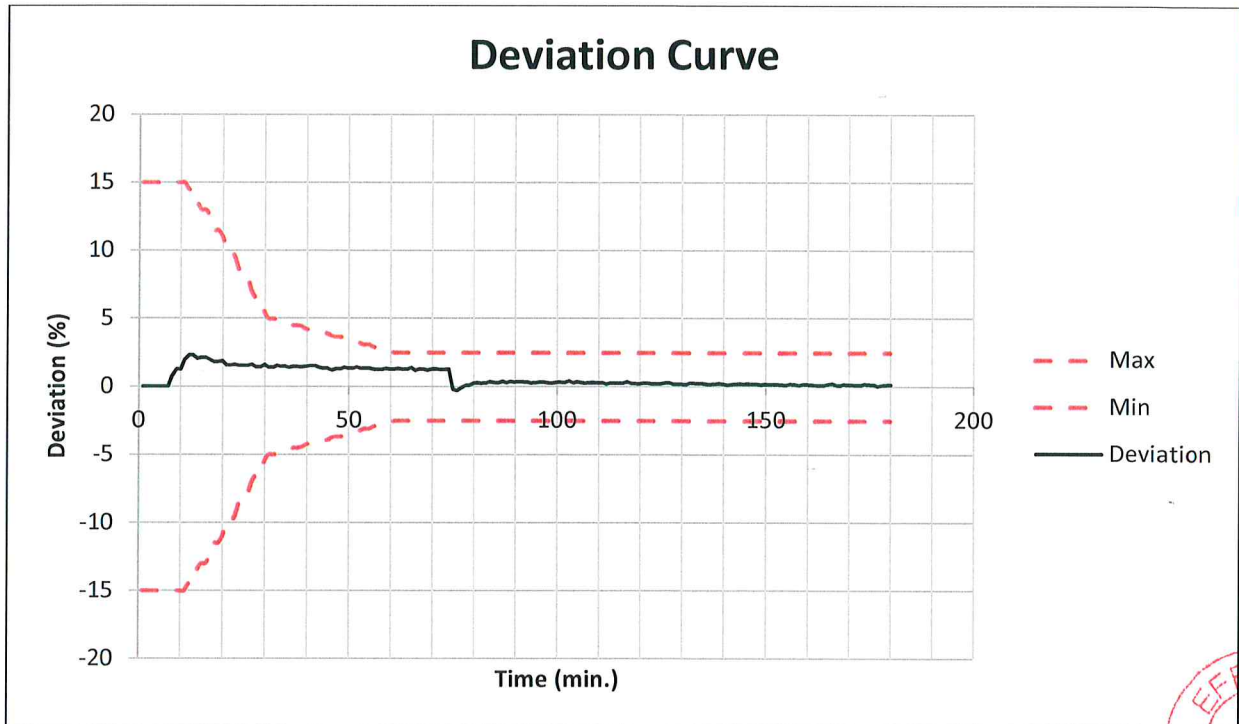
Figure A2: Deviation of furnace temperature

During the heating the temperature in the furnace complied with the standard EN 1363-1:2012

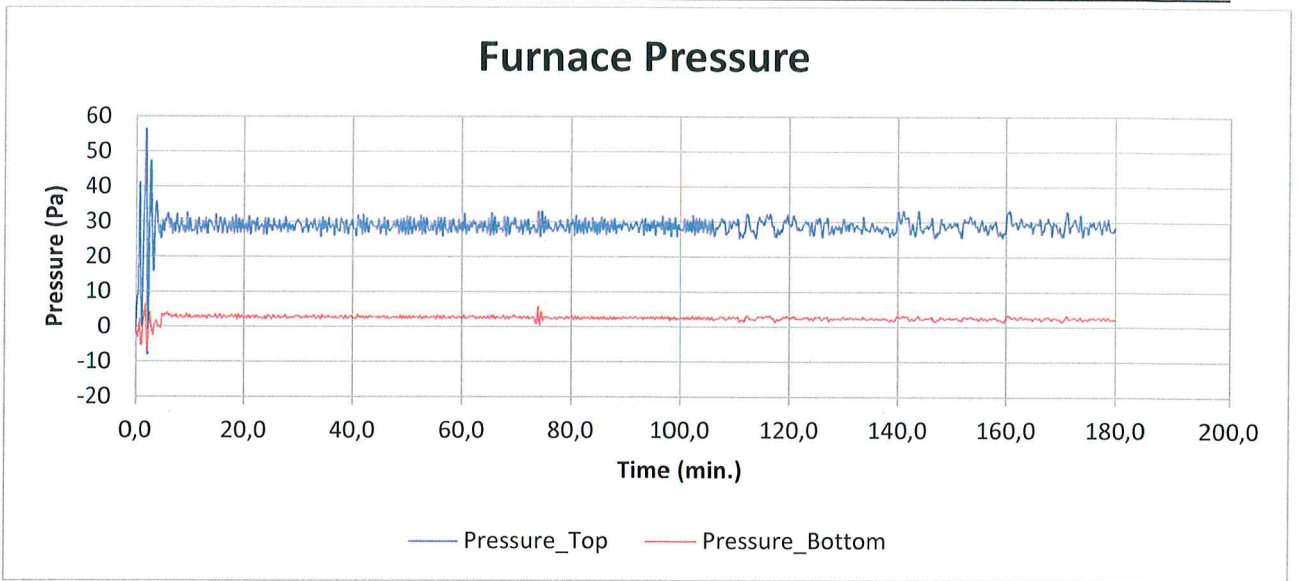
Figure A3: Pressure in the furnace

The target overpressure in the furnace was 15 Pa at centre of joints (1,25 m height).

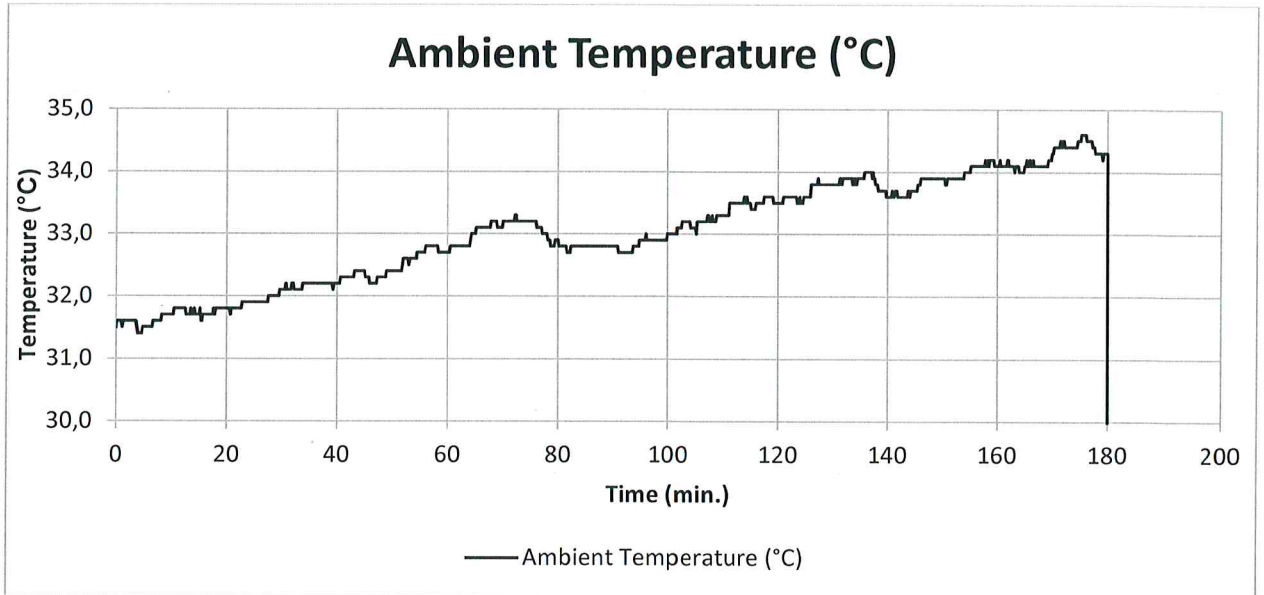
Figure A4: Ambient temperature at laboratory

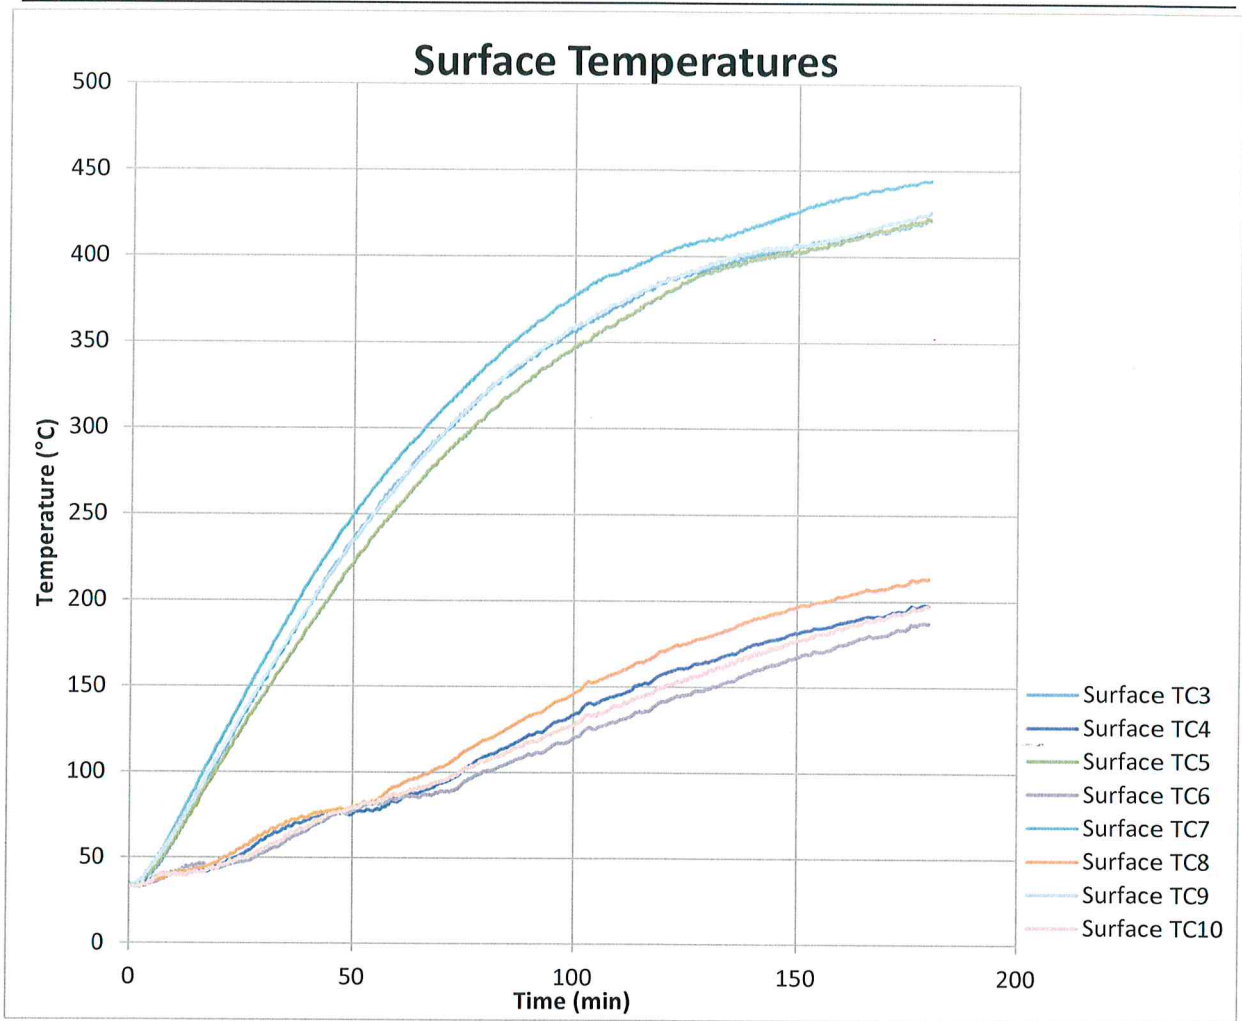
Figure B2: Surface temperatures of Intuflame 15 and Intuflame 20.

Seal reference	Examination		
	Integrity (E)		Insulation (I)
	Cotton pad	Flames longer than 10 s.	
Intuflame 15	N.A.	N	44 minutes by TC 3
Intuflame 20	N.A.	N	40 minutes by TC 7
Intuflame 30	N.A.	N	42 minutes by TC 11
Intuflame 40	N.A.	N	44 minutes by TC 15
Intuflame-H 15	N.A.	N	37 minutes by TC 19
Intuflame-H 20	N.A.	N	38 minutes by TC 25
Intuflame-H 30	N.A.	N	39 minutes by TC 27
Intuflame-H 40	N.A.	N	46 minutes by TC 33

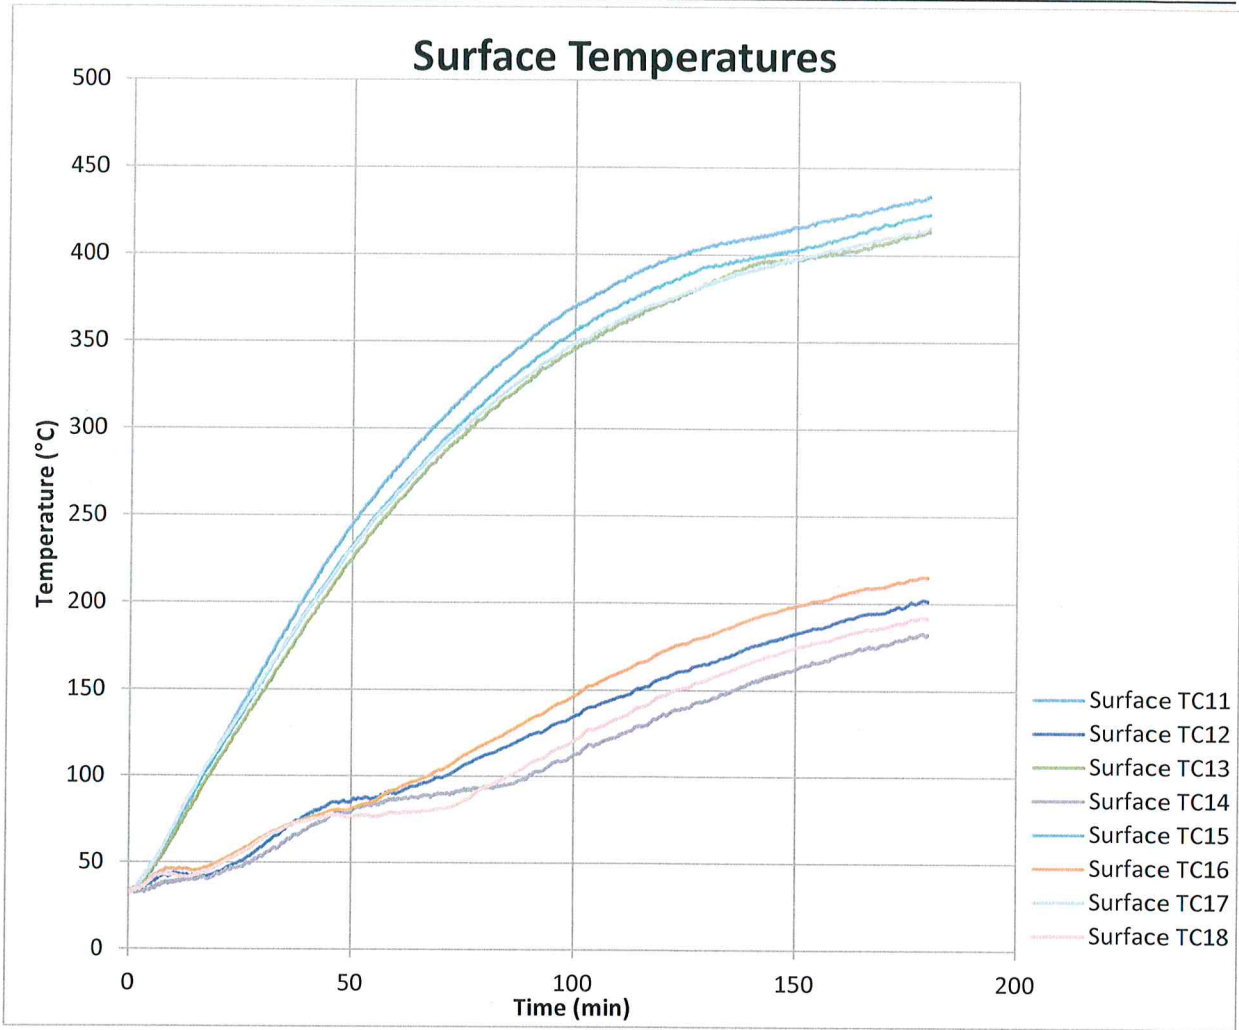
Figure B3: Surface temperatures of Intuflame 30 and Intuflame 40.

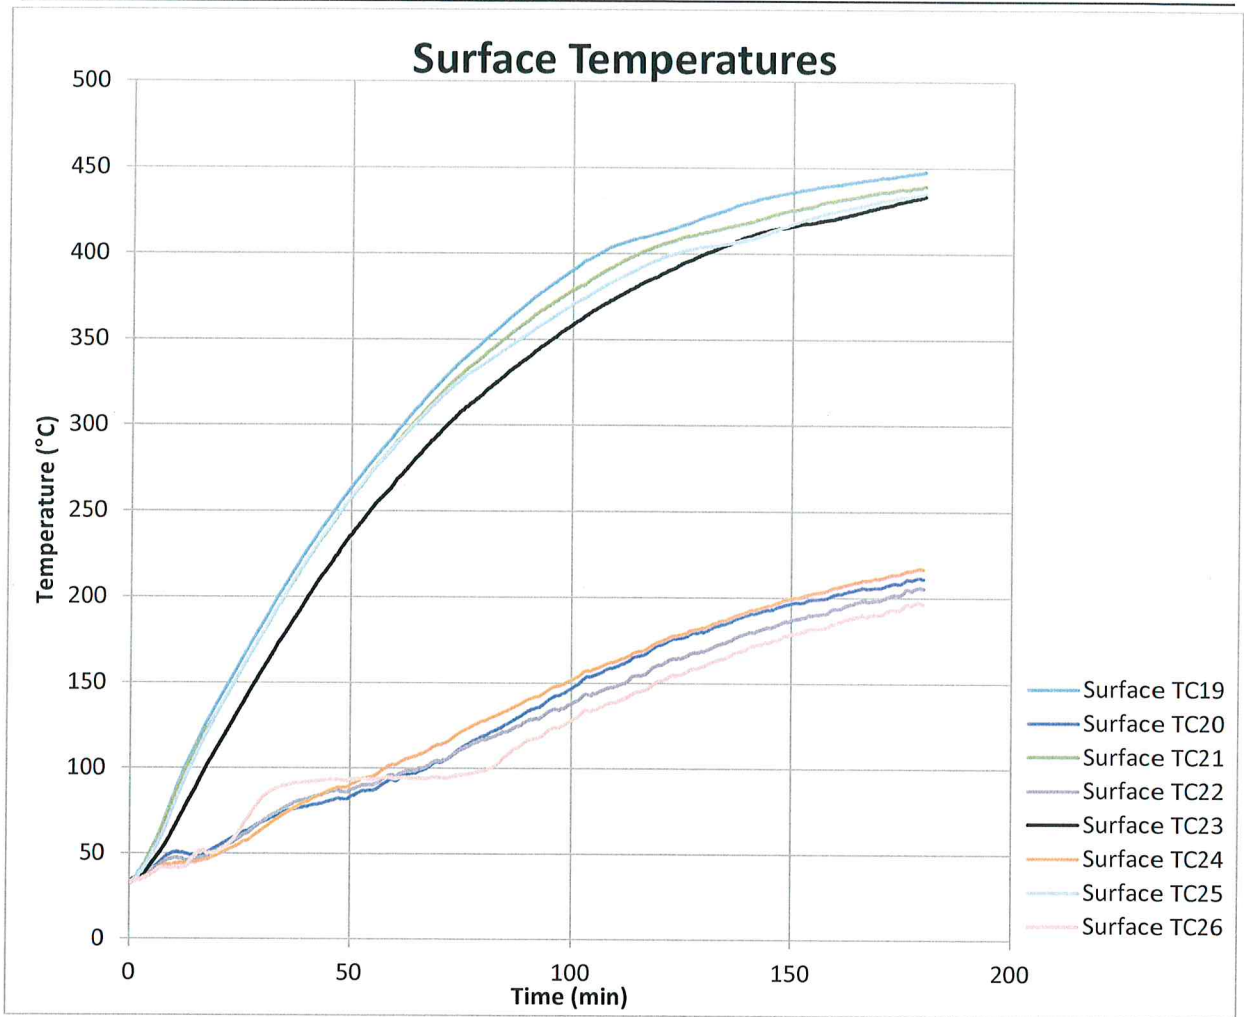
Figure B4: Surface temperatures of Intuflame-H 15 and Intuflame-H 20.

0	Heating started. See photo C1 and C2.
5	Seals started to expand.
28	Smoke release from bottom of the seals.
37	Temperature increased at Thermocouple Nr. 19, $\Delta T > 180$ °C. I failed for Intuflame-H 15.
38	Temperature increased at Thermocouple Nr. 25, $\Delta T > 180$ °C. I failed for Intuflame-H 20.
39	Temperature increased at Thermocouple Nr. 27, $\Delta T > 180$ °C. I failed for Intuflame-H 30.
40	Temperature increased at Thermocouple Nr. 7, $\Delta T > 180$ °C. I failed for Intuflame 20.
42	Temperature increased at Thermocouple Nr. 11, $\Delta T > 180$ °C. I failed for Intuflame 30.
44	Temperature increased at Thermocouple Nr. 3, $\Delta T > 180$ °C. I failed for Intuflame 15.
	Temperature increased at Thermocouple Nr. 15, $\Delta T > 180$ °C. I failed for Intuflame 40.
46	Temperature increased at Thermocouple Nr. 33, $\Delta T > 180$ °C. I failed for Intuflame-H 40.
60	No considerable changes, specimens continue to satisfy Integrity (E) criteria.

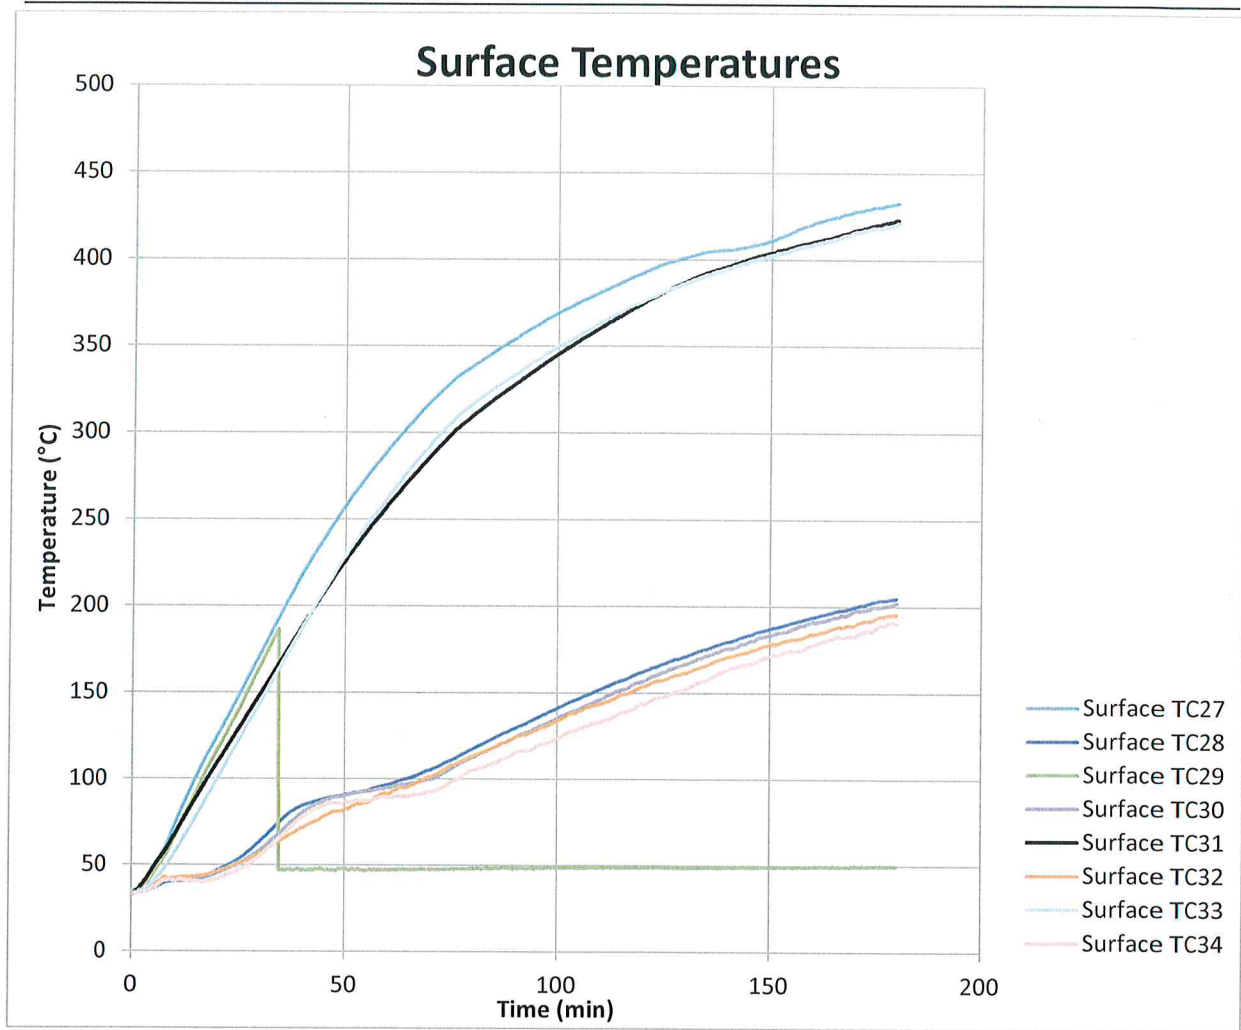
Figure B5: Surface temperatures of Intuflame-H 30 and Intuflame-H 40
(The connection of TC 29 sensor lost after 34 minutes).

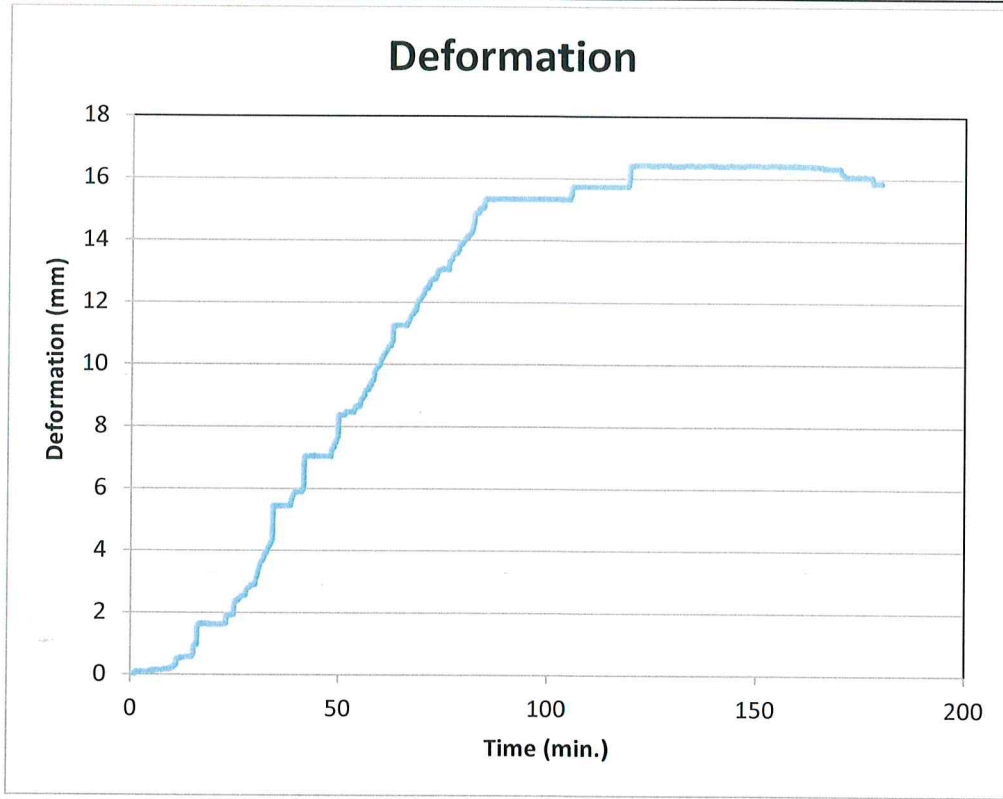
Figure B6: Deformation of the construction.

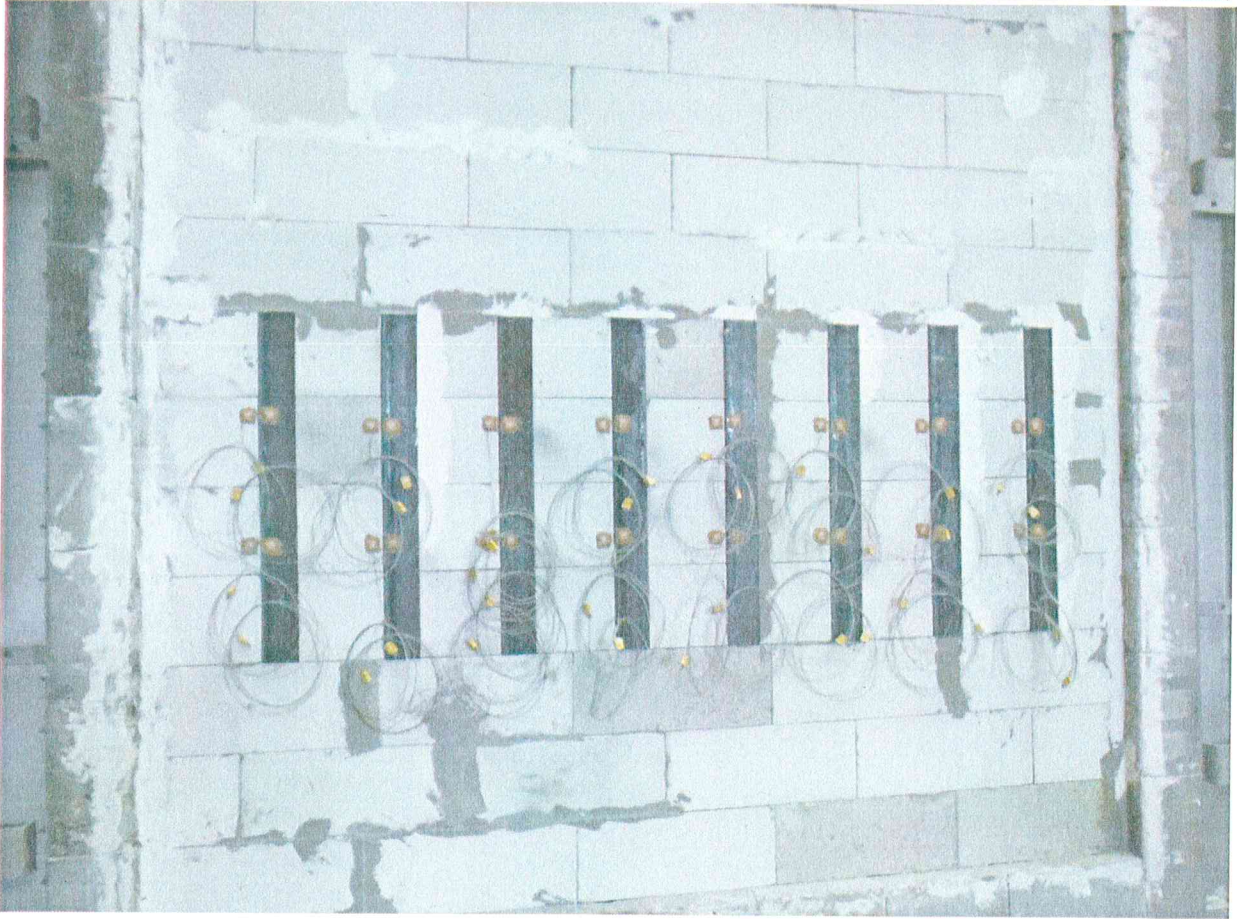
Photo C1: Unexposed side of the test construction before the test

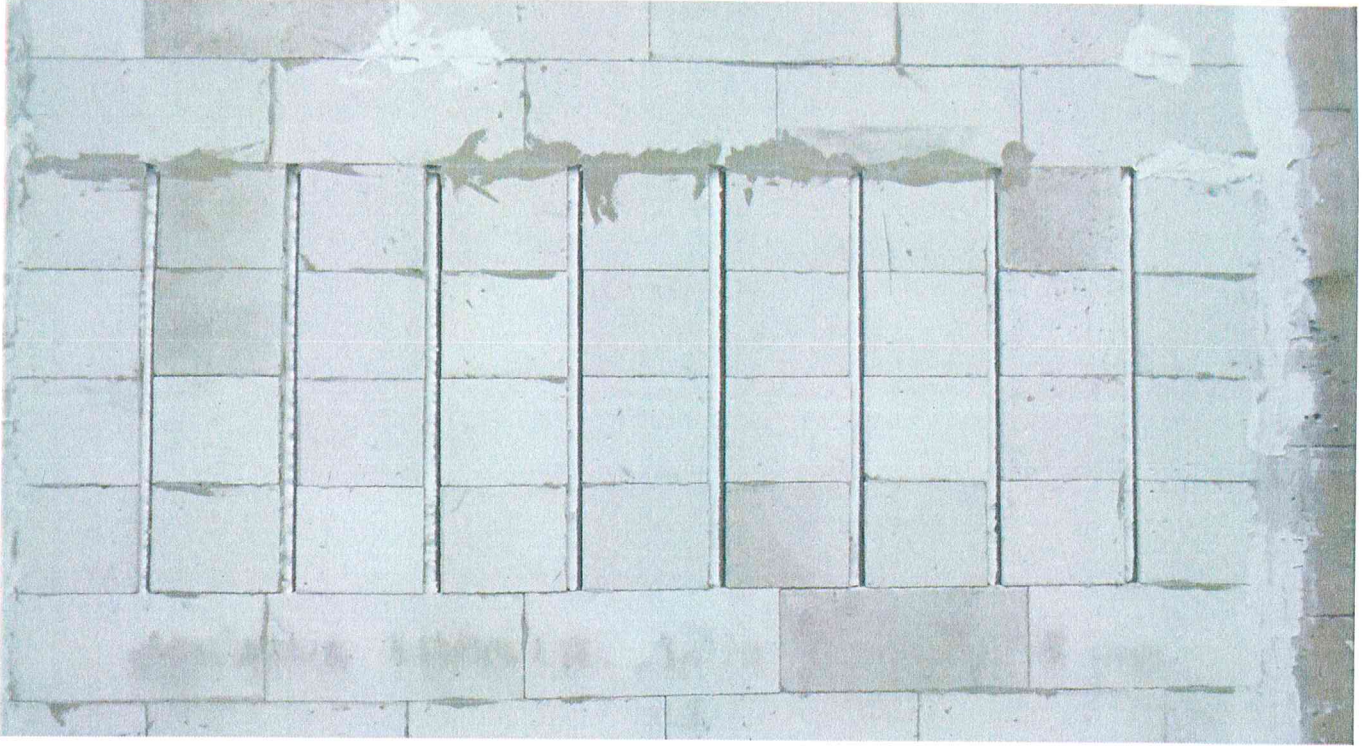
Photo C2: Exposed side of the test construction before the test

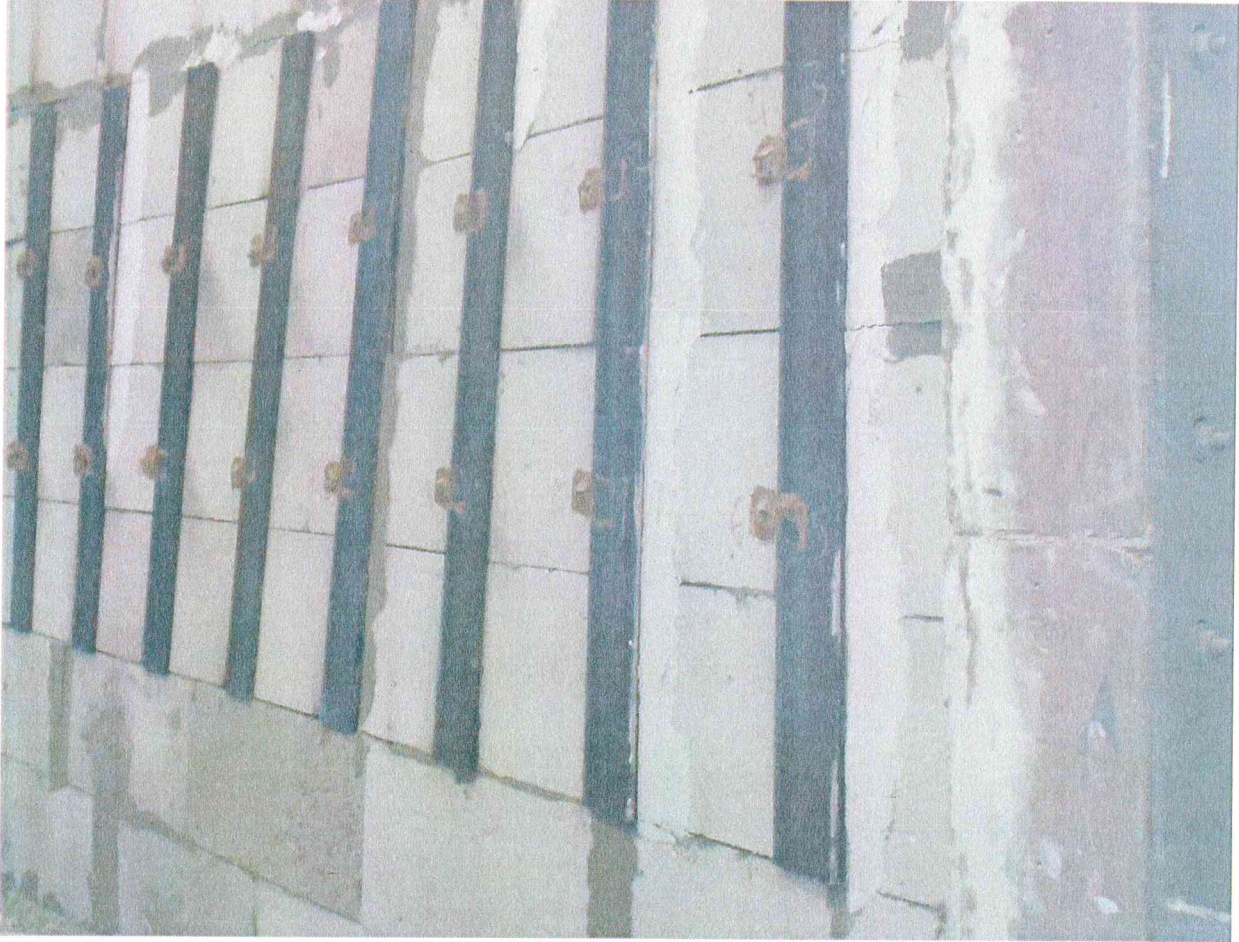
Photo C3: Unexposed side of the test specimens after the test.

120	No considerable changes, specimens continue to satisfy Integrity (E) criteria.
181	Test was terminated after consulted with the customer. See photo C3-C4.

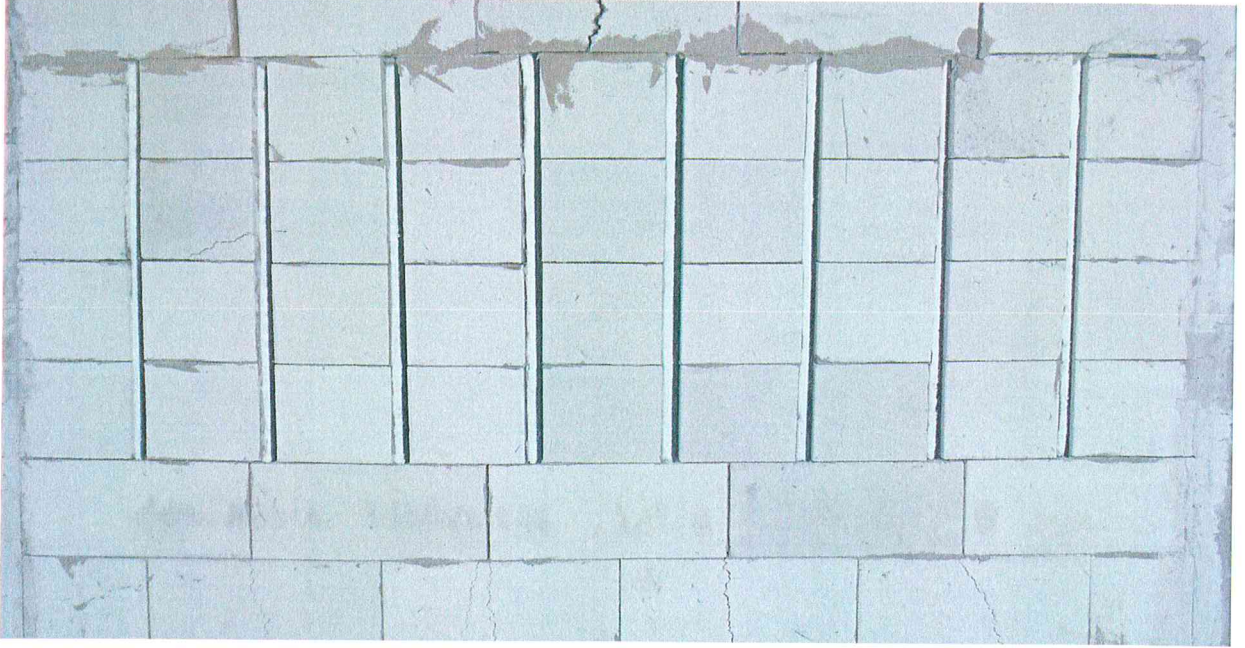
Photo C4: Exposed side of the test specimens after the test.
